Manhole Inspection Summary

Manhole # S03WW1011MH

Insp Date: **8/16/06 12:00 AM**

Location Address: **3500 Glen Ave**

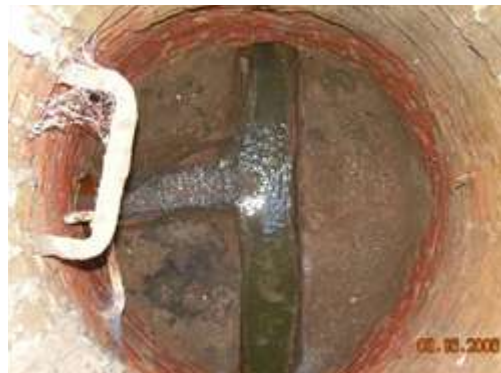
Top View

Adjustment and Corbel infiltration. Bench debris.

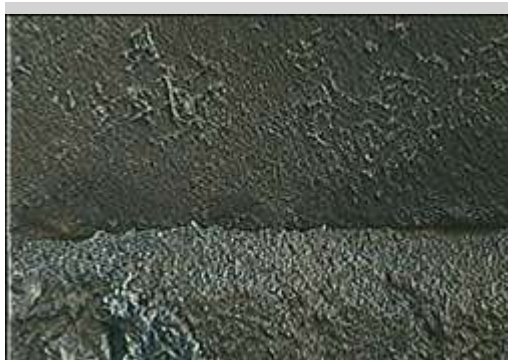
Defect

Frame leaks. Adjustment infiltration.

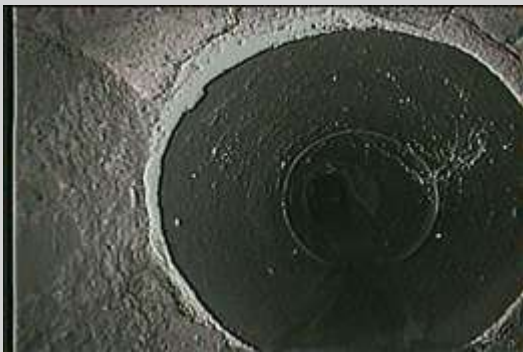
Pipe Out @ 12 O'Clock

Infiltration: **Evidence** Pipe Seal Cond: **Unknown**

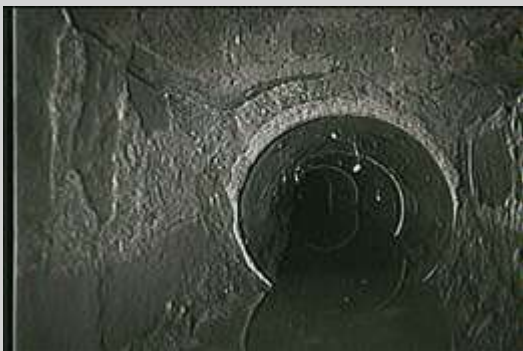
Pipe In @ 6 O'Clock

Infiltration: **Evidence** Pipe Seal Cond: **Unknown**

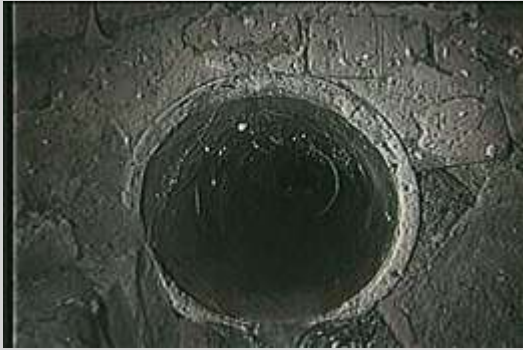
Pipe In @ 9 O'Clock

Infiltration: **Evidence**
